mornington island case study

Mornington Island Sewage Outfall

June 2008 – September 2008

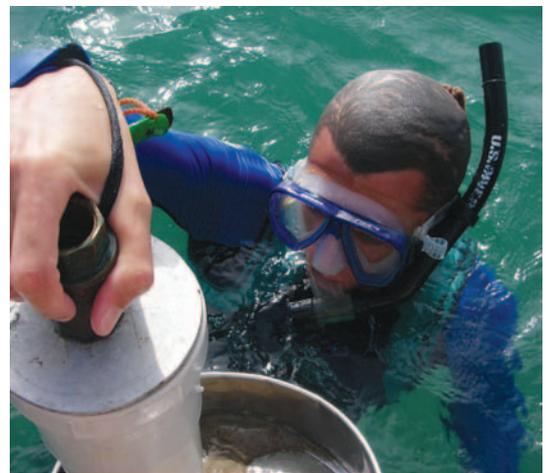
Collecting benthic samples - we use a variety of rigorous sampling techniques to ensure we get complete data, the first time.

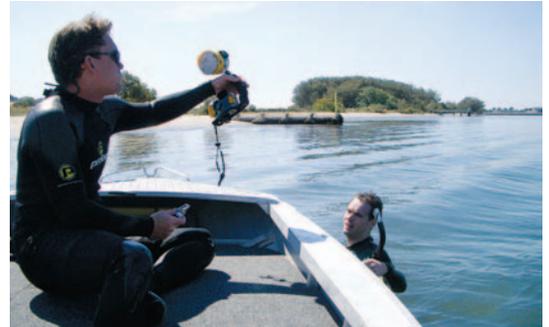
Preparing an underwater camera to take photos for Coral Point Count analysis, used to determine community composition and cover of benthic communities.

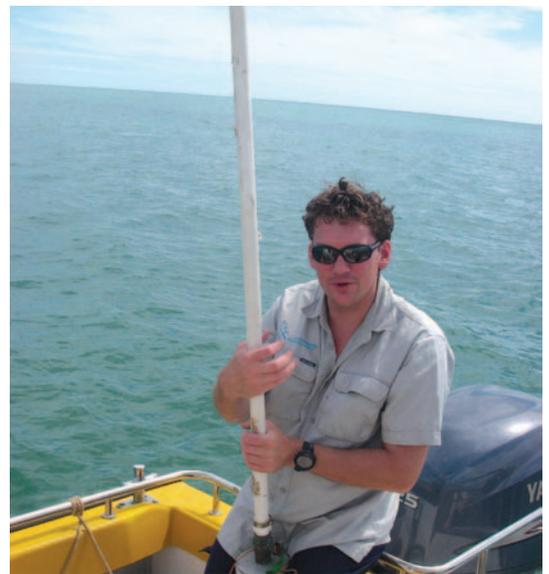
Ecologist preparing the corer to collect benthic samples – our extensive experience has provided us with highly efficient field techniques.

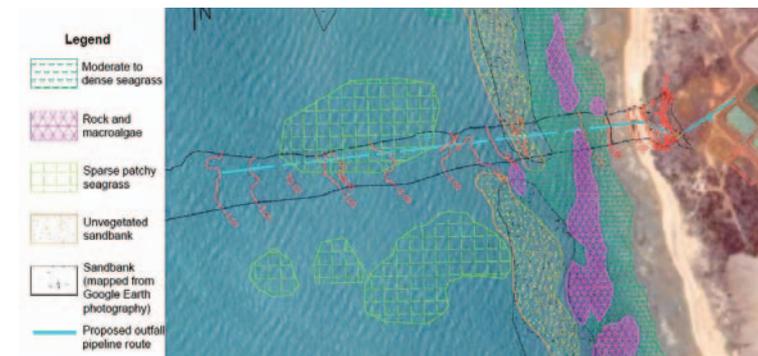
A map showing the distribution of seagrass, rocky reefs and sand banks in the vicinity of the proposed outfall pipeline.

In the field, our ecologists surveyed key intertidal and shallow sub-tidal habitat along and adjacent to the proposed alignment. An acceptable alternate alignment was negotiated to significantly reduce disturbance to seagrass meadows. Fringing reef corals were surveyed and their sensitivity to nutrient enrichment assessed. The impacts of existing effluent treatment and discharge were determined using *in situ* assessment of indicators such as seagrass epiphyte load and community structure, and laboratory-based isotope analysis of seagrass, mangrove and algal tissue.
